As most of you folks are aware by now on 15 Oct 2010 (10/287) at 15:23:21 UTC the AVHRR scan motor on NOAA-17 has stalled but not failed. The reason that it has not completely failed is because the motor is continuing to draw current but at a higher level. Engineers at NOAA speculate that the resistance caused by the break down in the lubrication within the scanner Subsystem as depicted in the diagram below (see figure 1.7)

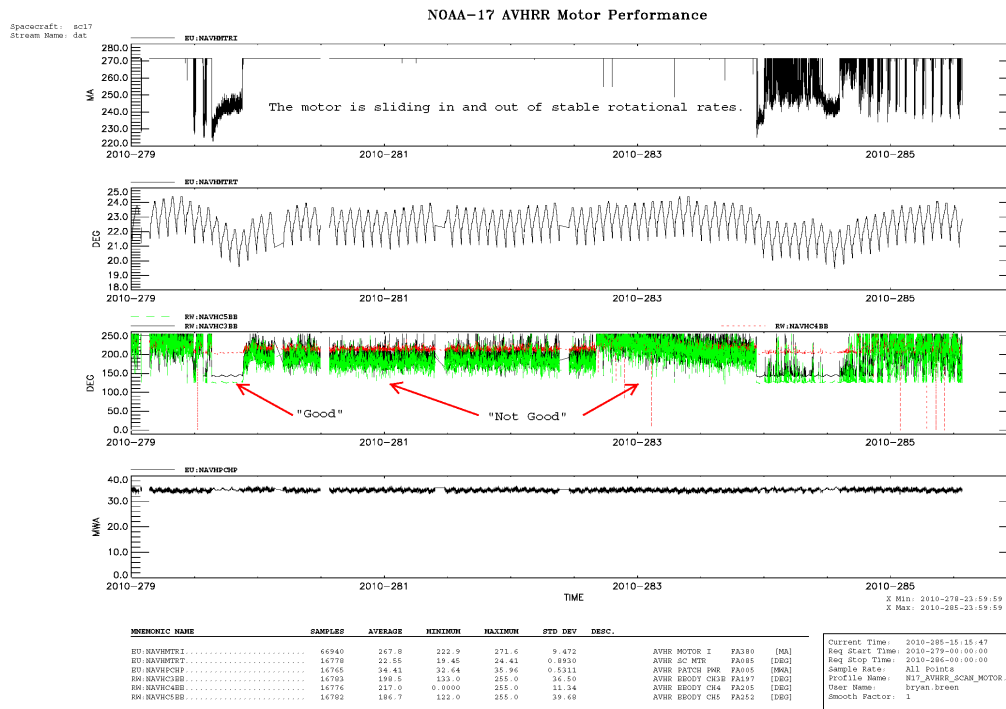
Figure-1

On 28 Sep 2010 (10/271) at 20:11:19 UTC the NOAA-17 AVHRR Scan Motor performance notably changed and is represented in the chart below from Oct 12. (see Figure 1). Motor resistance increased resulting in the current saturating above 270 mA and the Temperature rising 2 C. Science Data became unusable due to the unstable rotational rates.

This data is clearly supported in the anomaly currently observed in the AVHRR data by the user community. At the present NOAA has no plan to attempt any recovery procedures, as this effort would only prove to be ineffective. What we do know from previous missions is that some instruments like the NOAA-14 AVHRR did recover after 18 months that is represented in (Figure 2).
